WaveSculptor 22 Motor Drive
TRI88.012 ver 1
29 July 2013

WaveSculptor 22 Motor Drive Technical Note MPPT Compatibility

29 July 2013

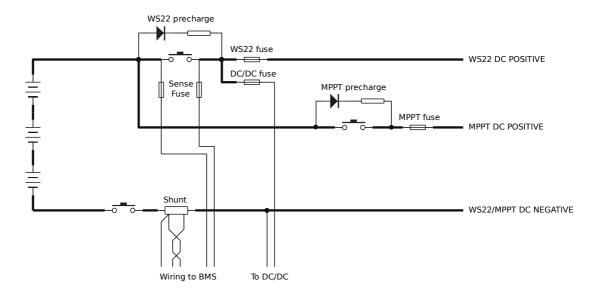
Boost MPPTs will often have a failure mode where the output voltage rises above the usual maximum during a load dump (disconnection under load) event.

In particular, the Drivetek MPPTs (as noted in the user's manual for the MPPTs) can potentially supply up to 236V during a DC disconnection event. Other makes are quite likely to be similar, depending on the energy in the boost inductor and output capacitors, and the control loop response times.

This voltage is far beyond the allowable 165V maximum on the WS22 motor controller, and will almost certainly cause damage to the power stage of the device, resulting in a failure shortly afterwards.

The problem arises if both the WS22 and the MPPTs are connected together on the vehicle side of the battery pack contactors / disconnects.

One possible solution to this problem is to have the WS22 and the MPPTs switched separately by the battery management system, such that when the pack HV connections are opened, the WS22 and MPPTs are also disconnected from each other, as well as from the battery pack. This is shown in the diagram below.

This solution means that the high voltage from the MPPTs is not seen by the WS22.

Note that the diode in the MPPT precharge circuit must be present to prevent high voltage coming back into the WS22 via the precharge resistors. This diode

must be rated to the maximum expected precharge current.

The BMS can still perform the normal precharge functionality on the WS22 by monitoring the voltage across the WS22 contactor.
